**Flood Control Project Maintenance  
Levee Inspections**  
**LMA District Cover Sheet**  
**Spring 2019 Levee Inspection Results**

**Butte County Department of Public Works**

**Spring 2019 Levee Inspection Results**

Waterway			Bank	Unit Miles
Unit No. 01 Mud Creek			Right	6.80
	Spring (March - May)	Summer (June - August)	(September - November) Fall	Winter (December - February)
Unit Maintenance Rating (Fall Only)				
Date of Inspection	4/10/2019 - 4/10/2019			
DWR Inspector	Makar Sokol			
Accompanied By

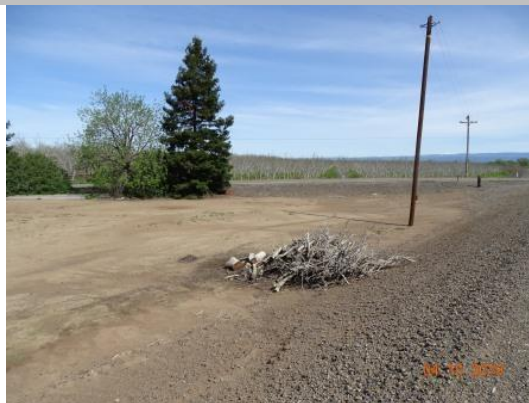
Photo 1 of 2 : SP\_2019\_NA0003\_64\_26\_20190415\_00063.jpg

View of the prunings at the landside toe. Spring 2019.

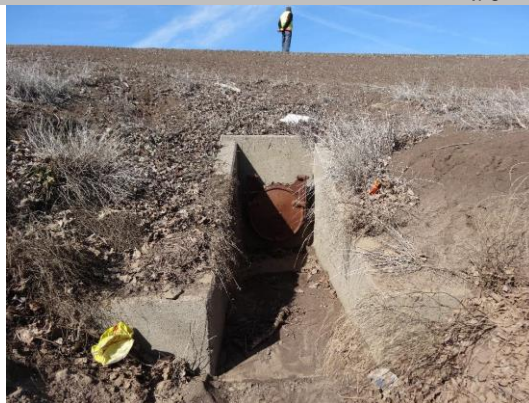
Photo 1 of 3 : UCIP\_SP\_2019\_29705\_54924.jpg

WS view: U typed concrete headwall, flapgate on levee slope.

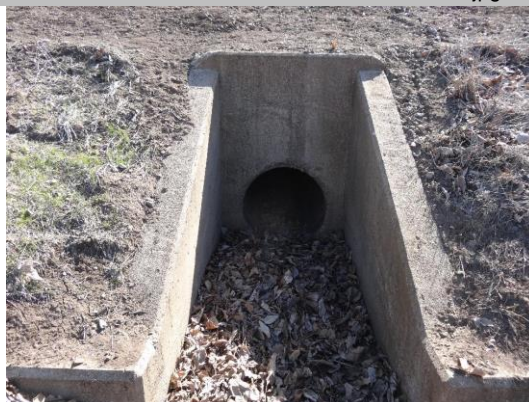
Photo 3 of 3 : UCIP\_SP\_2019\_32044\_58541.jpg

LS view: U typed concrete headwall and CMP on levee slope.

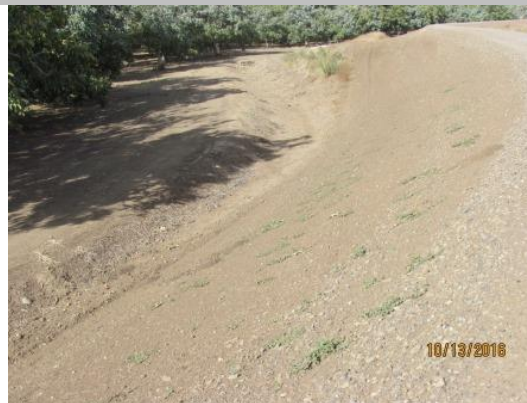
Photo 1 of 1 : SP\_2019\_NA0003\_64\_46\_20190325\_00023.jpg

LM Start	1.19	Rating **	M	Issue No.	46
LM End	1.25	Issue Type +	En	Location *	LS
Category	Earthen Levee			GPS Latitude/Longitude	
				Start	End
Item	Encroachments			39.740082 °	39.740697 °
				-121.928383 °	-121.927844 °
DWR ID	DWR_NA0003_01_f_2016_46				
Comment Code					
DT : Ditch					
Inspector Comment

View of a ditch along the toe.

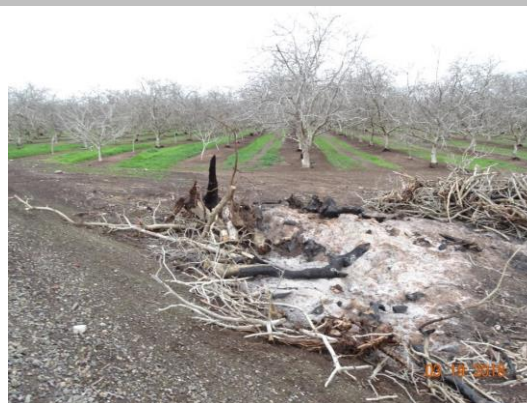
Photo 1 of 1 : SP\_2019\_NA0003\_64\_15\_20190325\_00003.jpg

View of the prunings along the landside toe.

LM Start	1.69	Rating **	M	Issue No.	15
LM End	1.69	Issue Type +	En	Location *	LS
Category	Earthen Levee			GPS Latitude/Longitude	
				Start	End
Item	Encroachments			39.745718 °	39.745718 °
				-121.923124 °	-121.923124 °
DWR ID	DWR_NA0003_01_s_2014_15				
Comment Code					
PR : Prunings					
Inspector Comment					
The prunings should be removed from the landside toe.

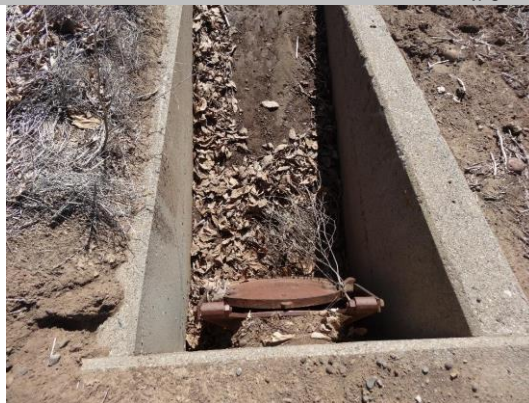
Photo 1 of 3 : UCIP\_SP\_2019\_50142\_55886.jpg

WS view: U type concrete headwall, flapgate on levee slope. Gate was not fully closed.

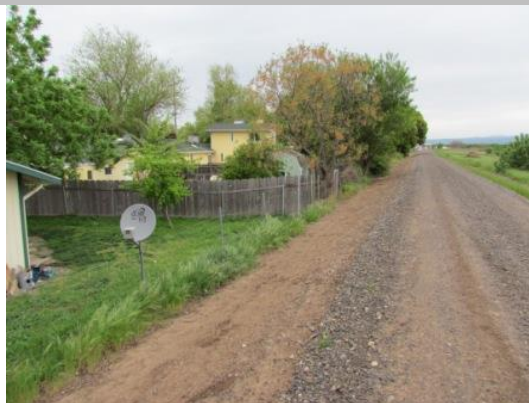
Photo 1 of 1 : SP\_2019\_NA0003\_64\_3\_20190325\_00002.jpg

LM Start	2.00	Rating **	M	Issue No.	3
LM End	2.04	Issue Type +	En	Location *	LS
Category	Earthen Levee			GPS Latitude/Longitude	
				Start	End
Item	Encroachments			39.748330 °	39.748867 °
				-121.918685 °	-121.918533 °
DWR ID	DWR_NA0003_01_s_2012_3				
Comment Code					
FE : Fence					
Inspector Comment

View of the fences along the landside toe.

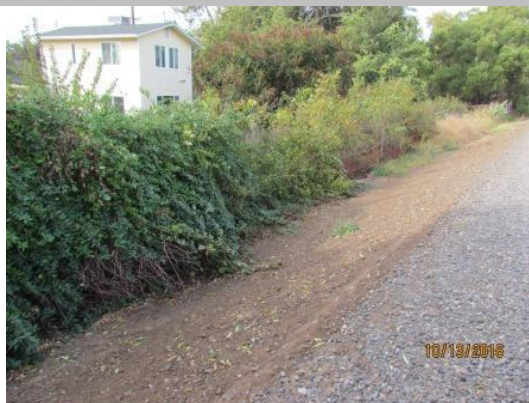
Photo 1 of 1 : SP\_2019\_NA0003\_64\_48\_20190325\_00024.jpg

LM Start	2.03	Rating **	M	Issue No.	48
LM End	2.11	Issue Type +	En	Location *	LS
Category	Earthen Levee			GPS Latitude/Longitude	
				Start	End
Item	Vegetation			39.748784 °	39.749872 °
				-121.918597 °	-121.918296 °
DWR ID	DWR_NA0003_01_f_2016_48				
Comment Code					
V6 : Landscaping					
Inspector Comment

View of landscaping vegetation blocking visibility.

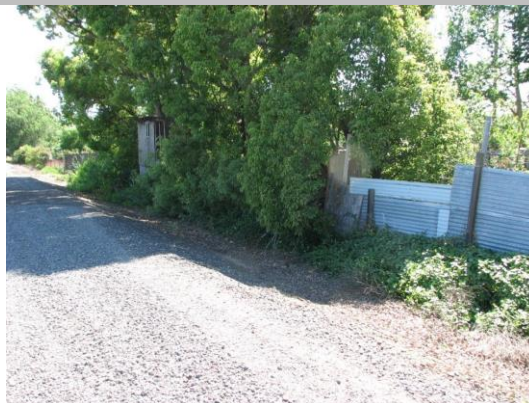
Photo 1 of 1 : SP\_2019\_NA0003\_64\_40\_20190325\_00021.jpg

LM Start	2.06	Rating **	U	Issue No.	40
LM End	2.08	Issue Type +	En	Location *	LS
Category	Earthen Levee			GPS Latitude/Longitude	
				Start	End
Item	Encroachments			39.749145 °	39.749461 °
				-121.918506 °	-121.918425 °
DWR ID	DWR_NA0003_01_s _ 2016_40				
Comment Code					
FE : Fence					
Inspector Comment					
Piecemeal corrugated fencing with vegetation is completely obscuring landside toe.

View of a metal fence and treehouse obstructing visibility and access.

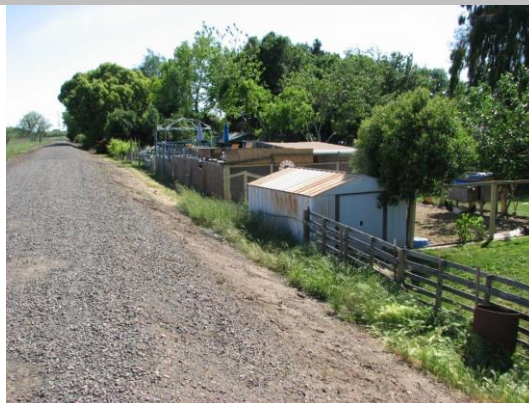
Photo 1 of 1 : SP\_2019\_NA0003\_64\_24\_20190325\_00006.jpg

LM Start	2.10	Rating **	U	Issue No.	24
LM End	2.10	Issue Type +	En	Location *	LS
Category	Earthen Levee			GPS Latitude/Longitude	
				Start	End
Item	Encroachments			39.749732 °	39.749732 °
				-121.918270 °	-121.918270 °
DWR ID	DWR_NA0003_01_s _ 2012_24				
Comment Code					
BU : Building					
Inspector Comment					
Shed and plank fencing are blocking visibility.

View of a metal shed and fence along the landside toe.

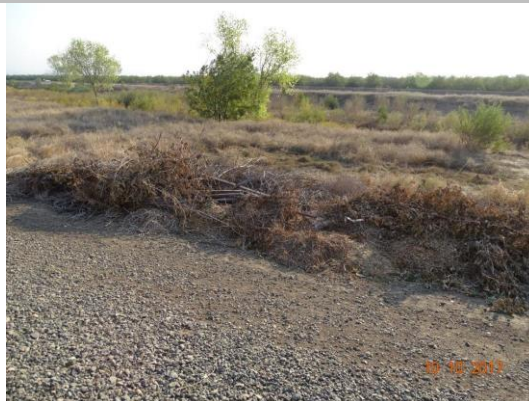
Photo 1 of 1 : SP\_2019\_NA0003\_64\_57\_20190325\_00031.jpg

View of the prunings along the waterside toe.

LM Start	2.12	Rating **	M	Issue No.	57
LM End	2.12	Issue Type +	En	Location *	WS
Category	Earthen Levee			GPS Latitude/Longitude	
				Start	End
Item	Encroachments			39.750037 °	39.750037 °
				-121.918237 °	-121.918237 °
DWR ID	DWR_NA0003_01_f_2017_57				
Comment Code					
PR : Prunings					
Inspector Comment					
The prunings should be removed from the waterside toe.

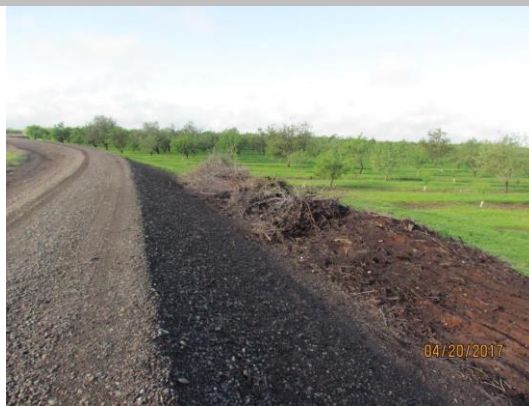
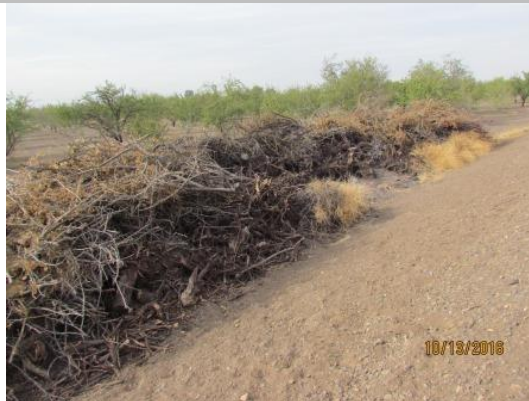
View of the prunings along the landside toe.

LM Start	2.59	Rating **	M	Issue No.	49
LM End	2.59	Issue Type +	En	Location *	LS
Category	Earthen Levee			GPS Latitude/Longitude	
				Start	End
Item	Encroachments			39.755930 °	39.755930 °
				-121.914829 °	-121.914829 °
DWR ID	DWR_NA0003_01_f_2016_49				
Comment Code					
PR : Prunings					
Inspector Comment					
The prunings should be removed from the landside toe.

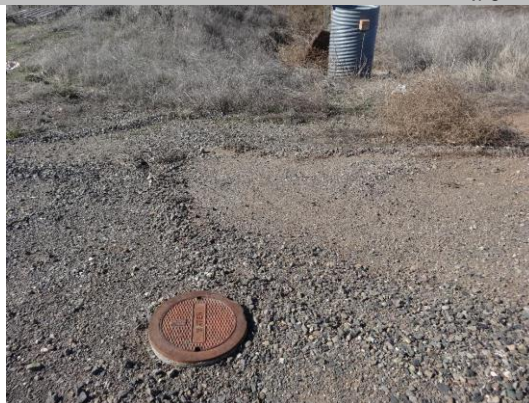
Photo 1 of 3 : UCIP\_SP\_2019\_30291\_55700.jpg

LS view: CMP riser on levee toe (top) and control box on levee shoulder (bottom).

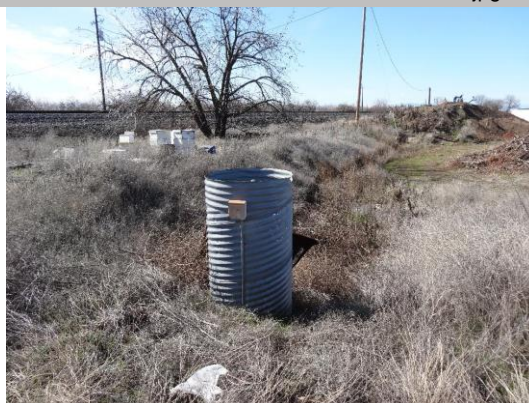
Photo 2 of 3 : UCIP\_SP\_2019\_30291\_55699.jpg

LS view: CMP riser on levee toe and drainage ditch perpendicular to the levee.

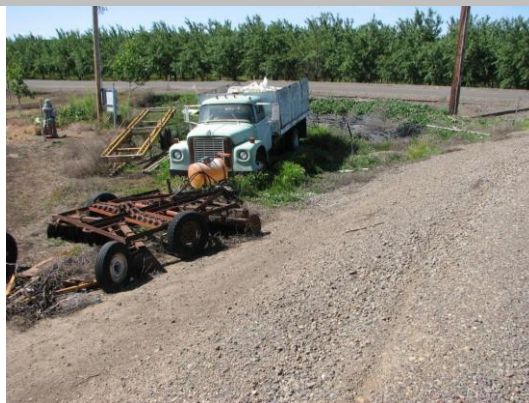
Photo 1 of 1 : SP\_2019\_NA0003\_64\_39\_20190325\_00020.jpg

LM Start	2.98	Rating **	M	Issue No.	39
LM End	2.98	Issue Type +	En	Location *	LS
Category	Earthen Levee			GPS Latitude/Longitude	
				Start	End
Item	Encroachments			39.760539 °	39.760539 °
				-121.911376 °	-121.911376 °
DWR ID	DWR_NA0003_01_s _ 2016_39				
Comment Code					
AV : Abandoned vehicles					
Inspector Comment					
Truck and farm equipment are blocking the landside toe.

View of equipment and vehicles along the landside toe.

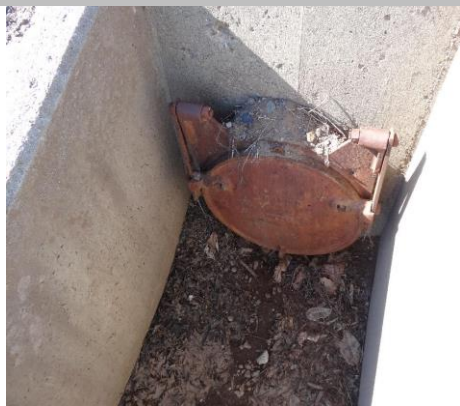
Photo 1 of 2 : UCIP\_SP\_2019\_30294\_55704.jpg

WS view: U type concrete headwall, flapgate on levee slope.

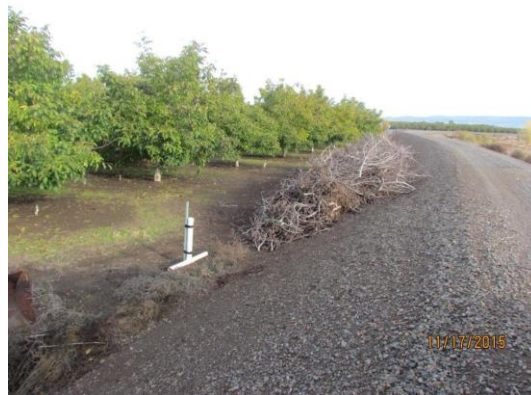
Photo 2 of 2 : SP\_2019\_NA0003\_64\_31\_20190325\_00013.jpg

View of the prunings and bait station along the landside slope.

LM Start	3.15	Rating **	M	Issue No.	31 (cont)	
LM End	3.15	Issue Type +	En	Location *	LS	
Category	Earthen Levee			GPS Latitude/Longitude		
				Start		End
Item	Encroachments			39.762565 °		39.762565 °
				-121.909873 °		-121.909873 °
DWR ID	DWR_NA0003_01_s_2015_31					
Comment Code						
PR : Prunings						
Inspector Comment						
The prunings should be removed from the landside slope.

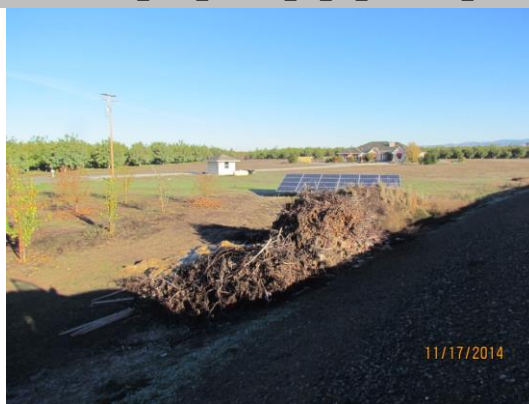
Photo 1 of 1 : SP\_2019\_NA0003\_64\_27\_20190325\_00008.jpg

View of the prunings along the landside toe.

LM Start	3.25	Rating **	M	Issue No.	27
LM End	3.25	Issue Type +	En	Location *	LS
Category	Earthen Levee			GPS Latitude/Longitude	
				Start	End
Item	Encroachments			39.763993 °	39.763993 °
				-121.909108 °	-121.909108 °
DWR ID	DWR_NA0003_01_f_2014_27				
Comment Code					
PR : Prunings					
Inspector Comment					
Remove the prunings from the landside slope.

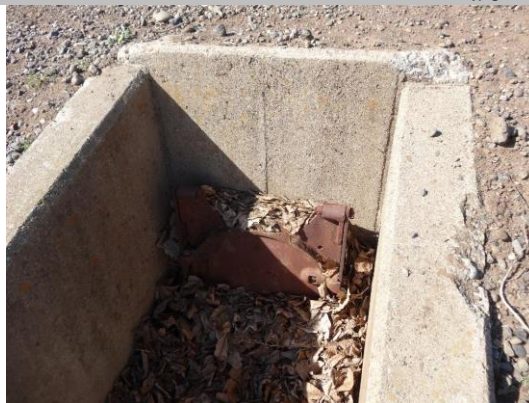
Photo 1 of 3 : UCIP\_SP\_2019\_30310\_55741.jpg

WS view: U type concrete headwall, pipe, and flapgate on levee slope. Vegetation debris blocking outlet.

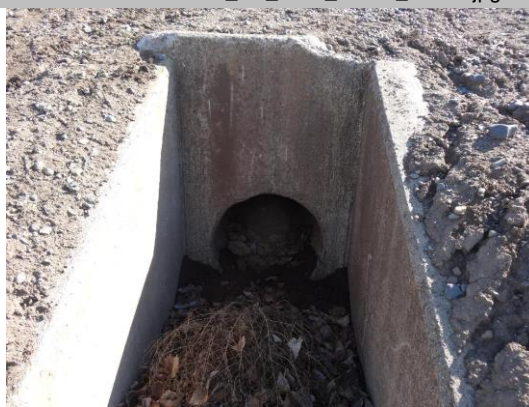
Photo 2 of 3 : UCIP\_SP\_2019\_30310\_55740.jpg

LS view: U type concrete headwall and CMP on levee slope.

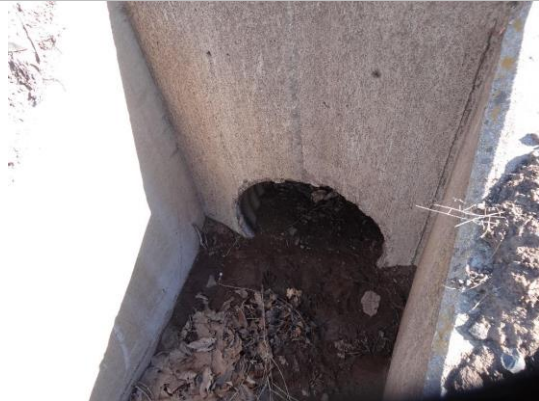
Photo 2 of 2 : UCIP\_SP\_2019\_30311\_55742.jpg

LS view: U type concrete headwall and CMP on levee slope.

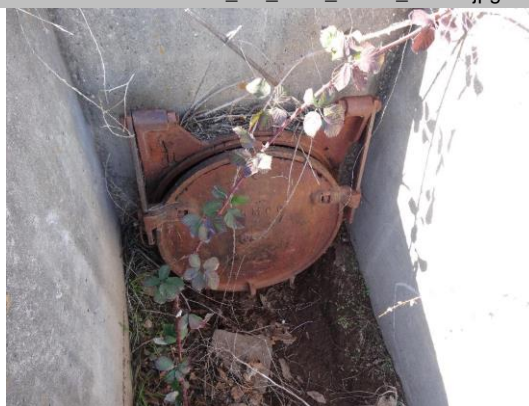
Photo 1 of 2 : UCIP\_SP\_2019\_30312\_55745.jpg

WS view: U type concrete headwall, pipe, and flapgate on levee slope. Vegetation debris blocking outlet.

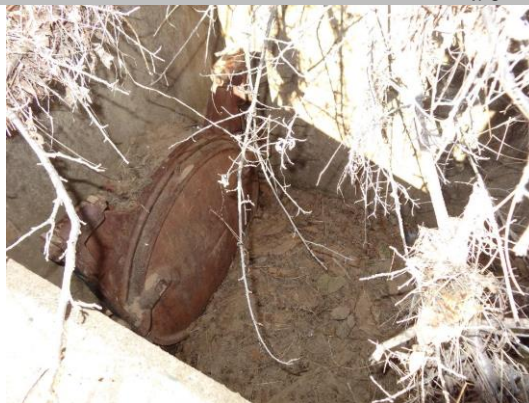
Photo 1 of 2 : UCIP\_SP\_2019\_30388\_55891.jpg

WS view: U type concrete headwall, pipe, and flapgate on levee slope. Vegetation/soil debris blocking outlet.

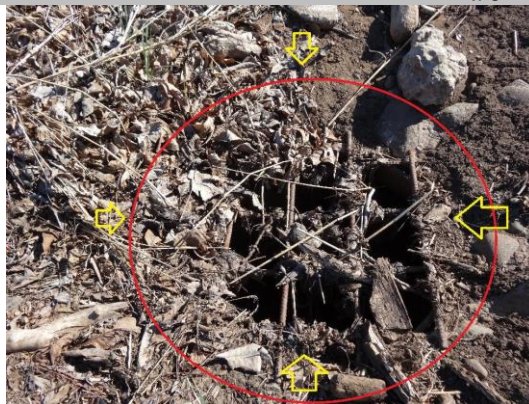
Photo 2 of 2 : UCIP\_SP\_2019\_30388\_55890.jpg

LS view: Underground CM standpipe intake with steel grit on levee toe.

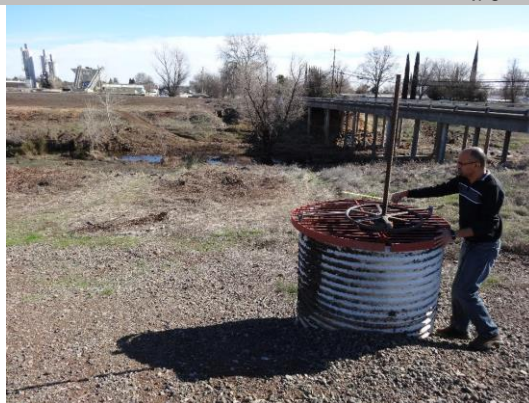
Photo 2 of 3 : UCIP\_SP\_2019\_30327\_55767.jpg

Comment Code						
Inspector Comment						
FS_ID:30327						
DS_ID:19222						
EP_NO: N/A						
Repair Type: No Action Needed						
Crossing Status: Found						
UCIP Comments: Slide gate in CM stadpipe on waterside levee slope.						
FIELD_STRUCT_DESC: 36-inch corrugated metal gravity drainage pipe						
through the levee, 17 feet below the crown. Slide gate in a corrugated						
metal standpipe on the waterside (WS) slope. Flap gate on the WS						
end. Concrete U-shaped headwall on each end. Grouted riprap apron						
on the landside (LS) end. Grouted riprap spillway on the WS end.						
[Additional Reference(s): DWR Levee Log, 1992. USACE Sacramento						
O&M Manual 504, May 1965, (HLM 5.22)].						
FS Date: 2/20/2014

WS view: CM standpipe with slide gate on levee slope.

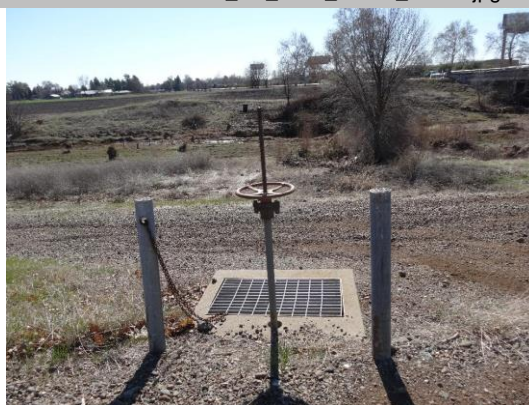
Photo 1 of 3 : UCIP\_SP\_2019\_30368\_55861.jpg

LM Start	5.30	Rating **	M	Issue No.	76
LM End	5.30	Issue Type +	En	Location *	
Category	Supplemental			GPS Latitude/Longitude	
				Start	End
Item	DWR UCIP Field Study			39.784739 °	39.784739 °
				-121.884860 °	-121.884860 °
DWR ID	19223				
Comment Code					
Inspector Comment					
FS_ID:30368 DS_ID:19223 EP_NO: N/A Repair Type: Non-Urgent Crossing Status: Found UCIP Comments: 12-inch steel pipe about 14 ft below the crown. FIELD_STRUCT_DESC: 12-inch steel drainage discharge pipeline through the levee, 14 feet below the crown. Slide gate in a concrete box on the waterside (WS) slope. Flap gate on the WS end. Grouted rock revetment on the WS slope. Three pumps on a concrete pad on the landside (LS). [Additional Reference(s): DWR Levee Log, 1992, 18-inch pipe referenced, 1 foot below the crown]. FS Date: 2/24/2014

WS view: slide gate in concrete box on levee slope.

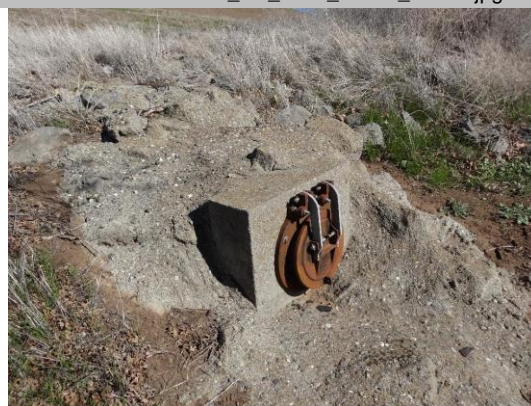
Photo 2 of 3 : UCIP\_SP\_2019\_30368\_55860.jpg

WS view: concrete headwall and flapgate on levee slope.

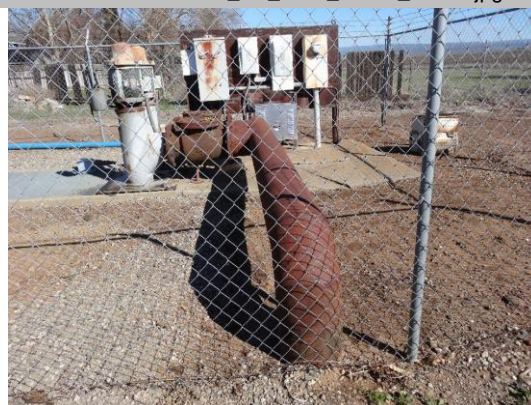
Photo 3 of 3 : UCIP\_SP\_2019\_30368\_55859.jpg

LS view: pipe, pumps, power boxes, concrete vault on landside.

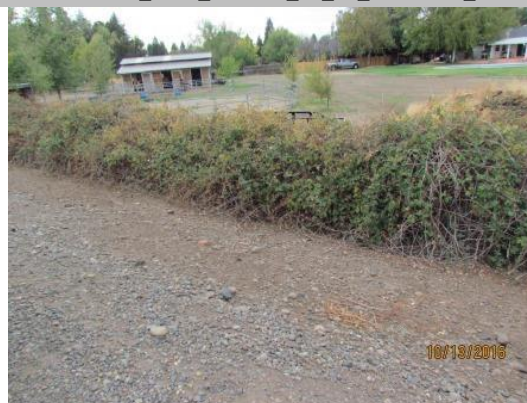
Photo 1 of 1 : SP\_2019\_NA0003\_64\_22\_20190325\_00005.jpg

LM Start	5.96	Rating **	M	Issue No.	22
LM End	5.96	Issue Type +	Ma	Location *	LS
Category	Earthen Levee			GPS Latitude/Longitude	
				Start	End
Item	Vegetation			39.793116 °	39.793116 °
				-121.887296 °	-121.887296 °
DWR ID	DWR_NA0003_01_f_2016_22				
Comment Code					
V2 : Remove the wild growth other than native grasses from the levee slopes.					
Inspector Comment					
The blackberry brambles should be removed from the landside toe and the 10' easement.

View of the blackberries blocking visibility and access.

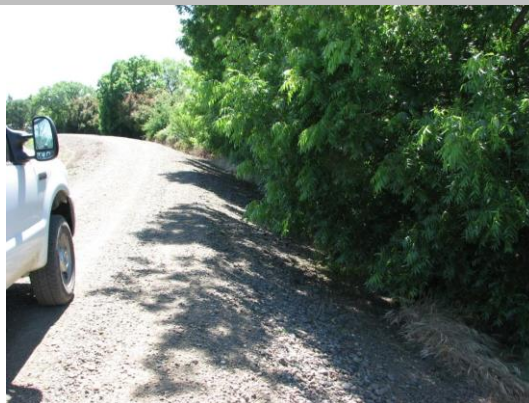
Photo 1 of 1 : SP\_2019\_NA0003\_64\_37\_20190325\_00018.jpg

LM Start	5.98	Rating **	U	Issue No.	37
LM End	6.13	Issue Type +	En	Location *	LS
Category	Earthen Levee			GPS Latitude/Longitude	
				Start	End
Item	Vegetation			39.793411 °	39.795145 °
				-121.887310 °	-121.885872 °
DWR ID	DWR_NA0003_01_s _ 2016_37				
Comment Code					
V6 : Landscaping					
Inspector Comment					
Various overgrown vegetation completely obscuring landside toe visibility.

04/25/2016: Trim trees on L/S slope.

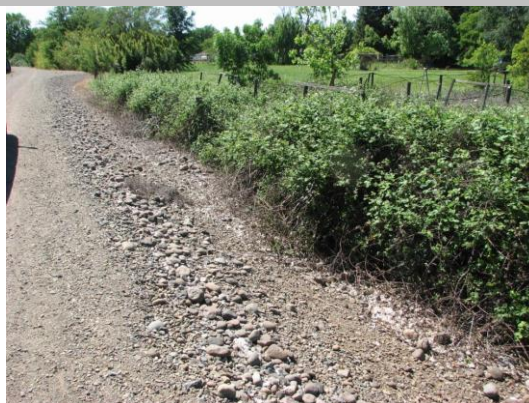
Photo 1 of 1 : SP\_2019\_NA0003\_64\_34\_20190325\_00016.jpg

LM Start	6.16	Rating **	M	Issue No.	34
LM End	6.16	Issue Type +	Ma	Location *	LS
Category	Earthen Levee			GPS Latitude/Longitude	
				Start	End
Item	Vegetation			39.795428 °	39.795428 °
				-121.885306 °	-121.885306 °
DWR ID	DWR_NA0003_01_s _ 2016_34				
Comment Code					
V2 : Remove the wild growth other than native grasses from the levee slopes.					
Inspector Comment					
Blackberry bramble should be removed from the landside toe.

Trim vegetation at L/S toe.

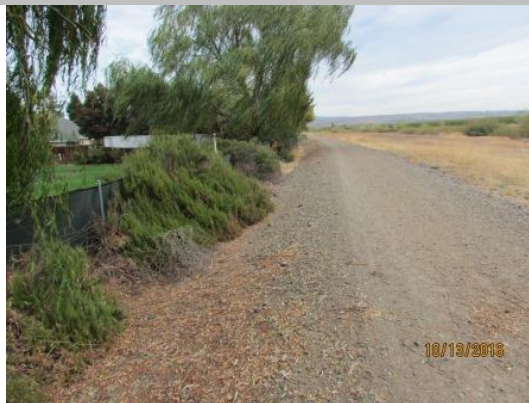
Photo 1 of 1 : SP\_2019\_NA0003\_64\_30\_20190325\_00011.jpg

LM Start	6.36	Rating **	M	Issue No.	30
LM End	6.39	Issue Type +	En	Location *	LS
Category	Earthen Levee			GPS Latitude/Longitude	
				Start	End
Item	Vegetation			39.797714 °	39.797884 °
				-121.883384 °	-121.882883 °
DWR ID	DWR_NA0003_01_s _ 2016_30				
Comment Code					
V6 : Landscaping					
Inspector Comment					
Rosemary landscaping covering landside toe.

View of the landscaping blocking visibility.

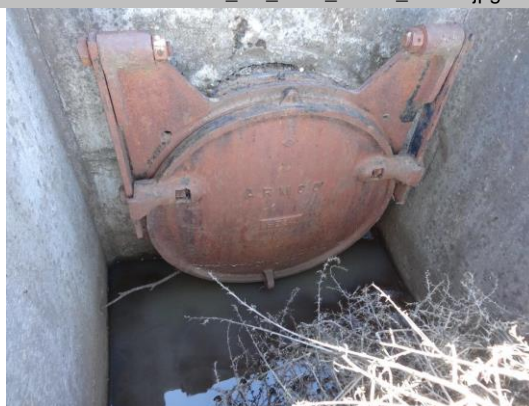
Photo 2 of 3 : UCIP\_SP\_2019\_31667\_57967.jpg

WS view: U type concrete headwall, pipe, and flapgate on levee slope. Vegetation debris on outlet box.

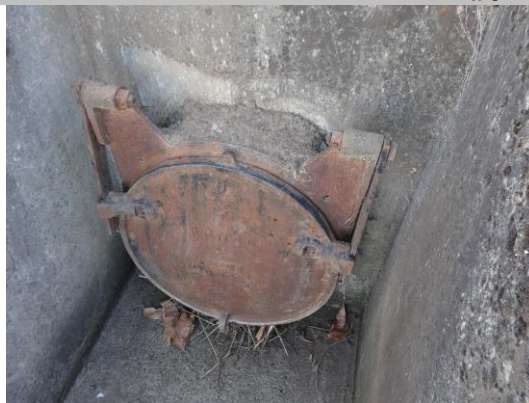
Photo 1 of 3 : UCIP\_SP\_2019\_30403\_55922.jpg

WS view: U type concrete headwall, pipe, and flapgate on levee slope.

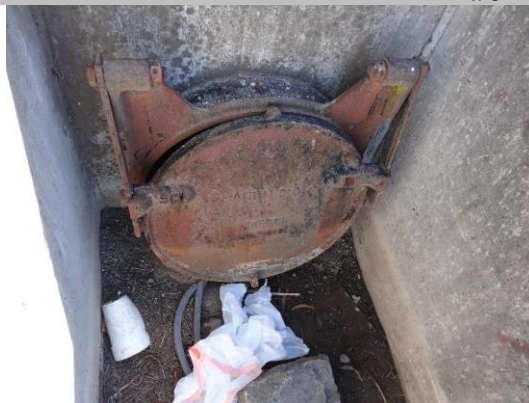
Photo 1 of 2 : UCIP\_SP\_2019\_30743\_56641.jpg

WS view: U type concrete headwall, pipe, and flapgate on levee slope.  
Debris in outlet box.

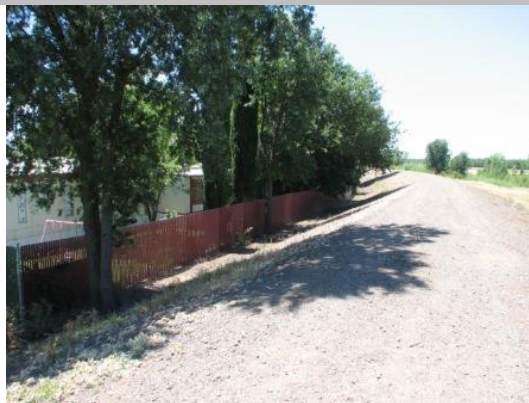
Photo 1 of 1 : SP\_2019\_NA0003\_65\_3\_20190325\_00002.jpg

LM Start	1.49	Rating **	U	Issue No.	3
LM End	1.81	Issue Type +	En	Location *	LS
Category	Earthen Levee			GPS Latitude/Longitude	
				Start	End
Item	Encroachments			39.782773 °	39.778972 °
				-121.888178 °	-121.891563 °
DWR ID	DWR_NA0003_02_s_2012_3				
Comment Code					
FE : Fence					
Inspector Comment

View of the fence along the landside toe of the levee.

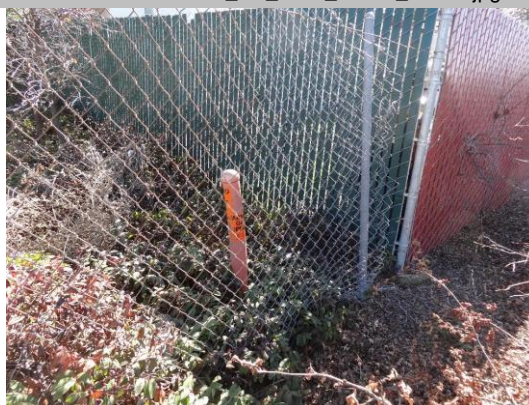
Photo 1 of 1 : UCIP\_SP\_2019\_41873\_56643.jpg

LM Start	1.49	Rating **	M	Issue No.	50
LM End	1.49	Issue Type +	En	Location *	
Category	Supplemental			GPS Latitude/Longitude	
				Start	End
Item	DWR UCIP Field Study			39.782766 °	39.782766 °
				-121.888187 °	-121.888187 °
DWR ID	24803				
Comment Code					
Inspector Comment					
FS_ID:41873 DS_ID:24803 EP_NO: 9874 Repair Type: Non-Urgent Crossing Status: Indicator Found UCIP Comments: May need to contact owner to determine status of crossing and install markers as appropriate. FIELD_STRUCT_DESC: 6-inch natural gas main of an unknown material through both levees and under Mud Creek, downstream from the Esplanade, at an unknown depth. Indicator on the landside (LS) toe. (Plans to install a 6-inch natural gas pipeline across Mud Creek and through adjacent levee authorized under Permit No. 9874, 1974 - Pacific Gas and Electric Company [PG&E]). FS Date: 2/24/2014

LS view: gasline marker on levee toe.

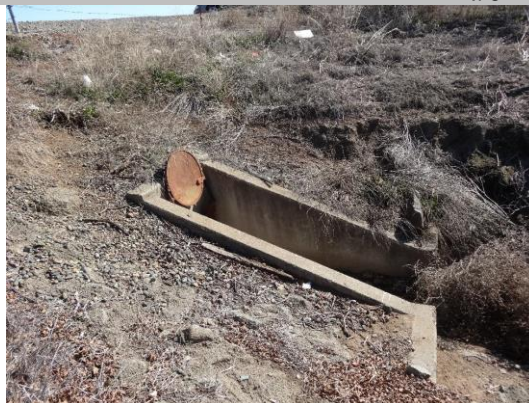
Photo 1 of 3 : UCIP\_SP\_2019\_41375\_56646.jpg

Comment Code					
Inspector Comment					
FS_ID:41375 DS_ID:19238 EP_NO: 12619A Repair Type: Non-Urgent Crossing Status: Found UCIP Comments: - 24-inch CM pipe.- inlet and spillway may need cleaning and clearing. FIELD_STRUCT_DESC: 24-inch corrugated metal gravity storm drainage pipe through the levee, 11 feet below the crown. Flap gate on the waterside (WS) end. Concrete U-shaped headwall on each end. Grouted riprap apron on the landside (LS) end. Grouted riprap spillway on the WS end. (Plans to replace an existing 24-inch storm drain inlet to the Mud Creek Diversion Channel with a 36-inch storm drain located approximately 500 feet upstream from Nord Highway authorized under Permit No. 12619, 1979 - Richard E. Vermillion. Plans for extension of time to replace an existing 24-inch storm drain inlet to the Mud Creek Diversion Channel with a 36-inch storm drain located upstream from Nord Highway authorized under Permit No. 12619-A, 1980 - Richard E. Vermillion). The storm drain never got replaced. [Additional Reference(s): DWR Levee Log, 1992, 36-inch pipe referenced. USACE Sacramento O&M Manual 504, May 1965, (HLM 2.13)]. FS Date: 2/24/2014

WS view: U type concrete headwall and flapgate on levee slope. Vegetation debris on spillway.

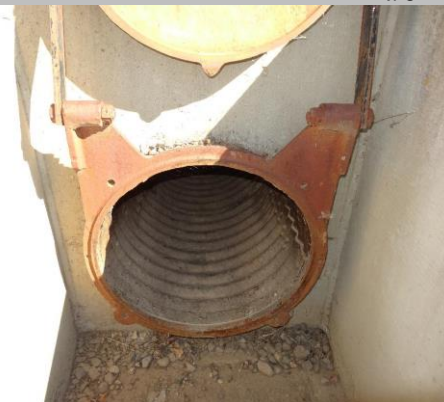
Photo 2 of 3 : UCIP\_SP\_2019\_41375\_56645.jpg

WS view: U type concrete headwall, pipe, and flapgate on levee slope.

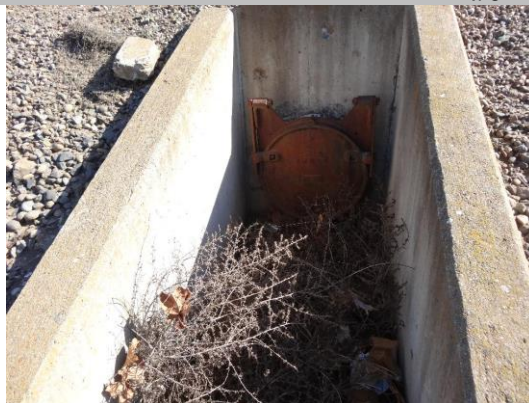
Photo 1 of 3 : UCIP\_SP\_2019\_30763\_56662.jpg

WS view: U type concrete headwall, pipe, and flapgate on levee slope.  
Vegetation debris blocking outlet.

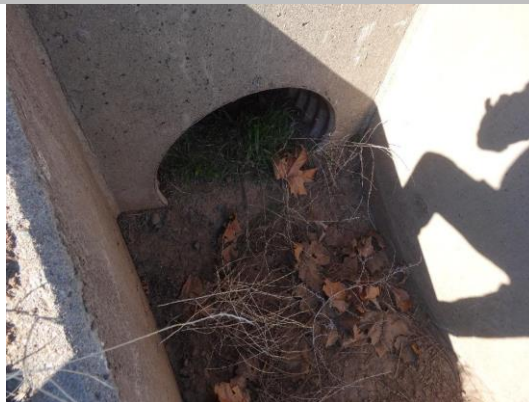
Photo 2 of 3 : UCIP\_SP\_2019\_30763\_56661.jpg

LS view: U type concrete headwall and CMP on levee slope.

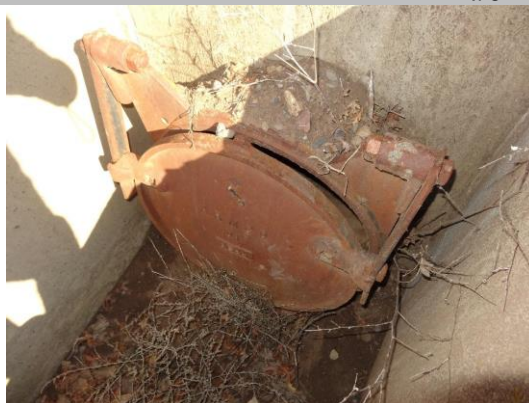
Photo 1 of 3 : UCIP\_SP\_2019\_30783\_56682.jpg

WS view: U type concrete headwall, pipe, and flapgate on levee slope. Gate not fully closed. Debris and soil in outlet box.

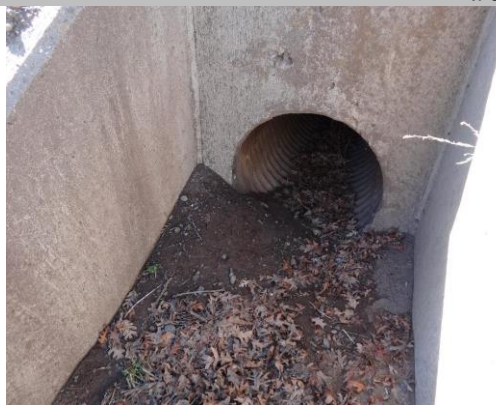
Photo 2 of 3 : UCIP\_SP\_2019\_30783\_56681.jpg

LS view: U type concrete headwall and CMP on levee slope. Debris and soil in inlet box.

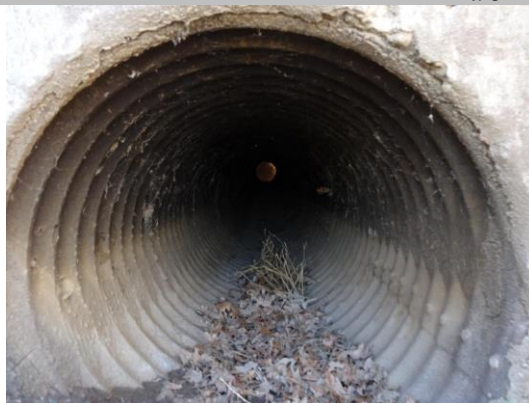
Photo 3 of 3 : UCIP\_SP\_2019\_30783\_56680.jpg

LS view: inside view of CMP on levee slope. Needs cleaning and clearing.

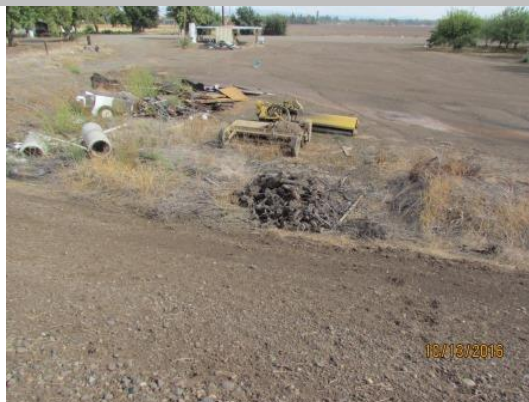
Photo 1 of 1 : SP\_2019\_NA0003\_65\_1\_20190325\_00001.jpg

LM Start	2.80	Rating **	M	Issue No.	1
LM End	2.80	Issue Type +	En	Location *	LS
Category	Earthen Levee			GPS Latitude/Longitude	
				Start	End
Item	Encroachments			39.767841 °	39.767841 °
				-121.901534 °	-121.901534 °
DWR ID	DWR_NA0003_02_f_2013_1				
Comment Code					
FW : Firewood					
Inspector Comment					
Firewood and broken concrete pipes should be removed from the landside toe.

View of the firewood and broken concrete pipes along the landside toe.

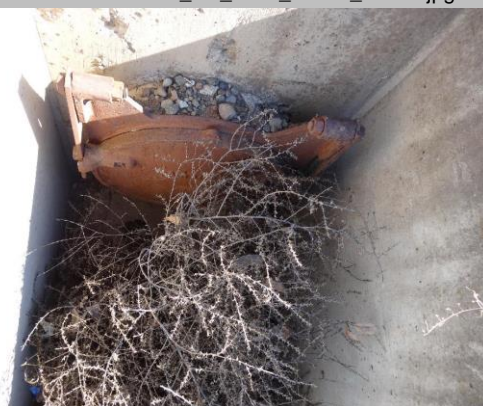
Photo 1 of 3 : UCIP\_SP\_2019\_30803\_56685.jpg

WS view: U type concrete headwall, pipe, and flapgate on levee slope. Vegetation debris and soil blocking outlet.

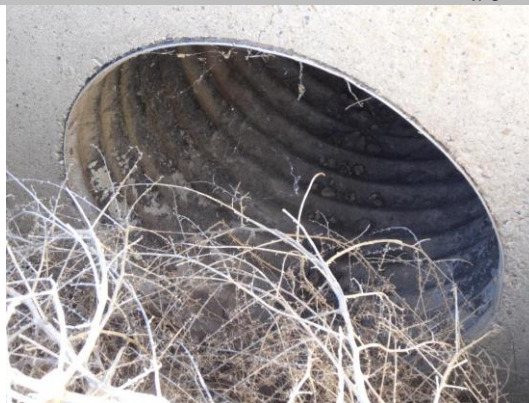
Photo 3 of 3 : UCIP\_SP\_2019\_30803\_56683.jpg

LS view: inside view of CMP on levee slope. Needs cleaning and clearing.

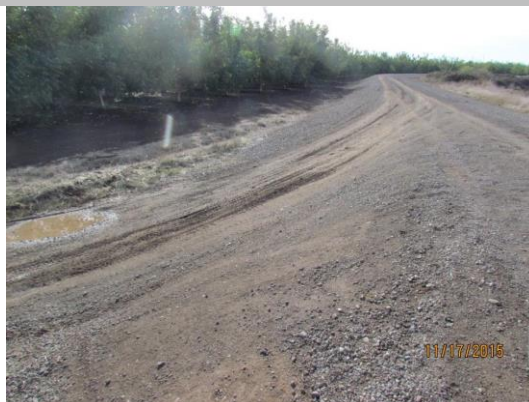
Photo 1 of 1 : SP\_2019\_NA0003\_65\_10\_20190325\_00004.jpg

LM Start	3.52	Rating **	M	Issue No.	10
LM End	3.52	Issue Type +	Ma	Location *	LS
Category	Earthen Levee			GPS Latitude/Longitude	
				Start	End
Item	Slope Stability			39.760582 °	39.760582 °
				-121.910303 °	-121.910303 °
DWR ID	DWR_NA0003_02_f_2015_10				
Comment Code					
S3 : Repair the levee slope damaged by vehicle traffic and prevent access where possible.					
Inspector Comment

View of the vehicle erosion along the landside slope.

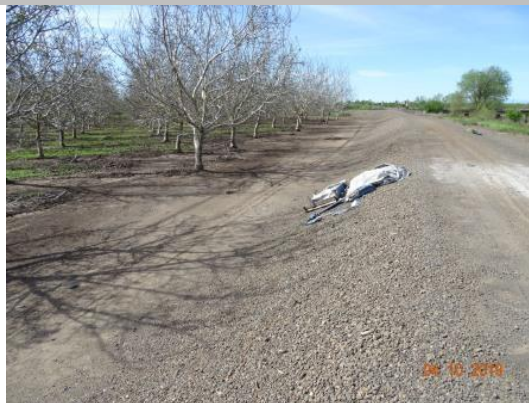
Photo 1 of 1 : SP\_2019\_NA0003\_65\_40\_20190415\_00065.jpg

LM Start	3.75	Rating **	M	Issue No.	40
LM End	3.75	Issue Type +	Ma	Location *	LS
Category	Earthen Levee			GPS Latitude/Longitude	
				Start	End
Item	Encroachments			39.757831 °	39.757831 °
				-121.911920 °	-121.911920 °
DWR ID	DWR_NA0003_02_s_2019_40				
Comment Code					
DE : Debris					
Inspector Comment					
The pile of debris should be removed from the landside slope.

View of a pile of debris on the landside slope. Spring 2019.

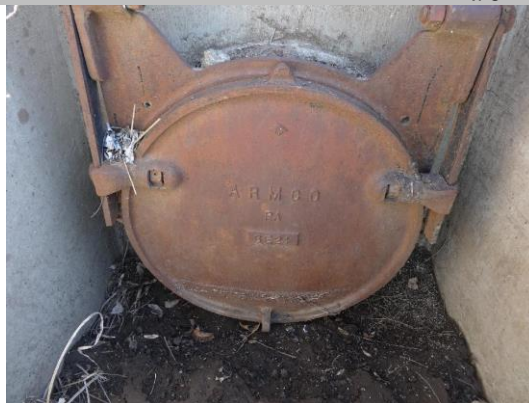
Photo 1 of 3 : UCIP\_SP\_2019\_31028\_56913.jpg

LM Start	4.61	Rating **	M	Issue No.	55
LM End	4.61	Issue Type +	Ma	Location *	
Category	Supplemental			GPS Latitude/Longitude	
				Start	End
Item	DWR UCIP LMA Responsibility			39.748731 °	39.748731 °
				-121.917577 °	-121.917577 °
DWR ID	19245				
Comment Code					
Inspector Comment					
FS_ID:31028 DS_ID:19245 EP_NO: N/A Repair Type: Non-Urgent Crossing Status: Found UCIP Comments: Needs cleaning and clearing of debris. FIELD_STRUCT_DESC: 24-inch corrugated metal gravity drainage pipe through the levee, 10 feet below the crown. Flap gate on the waterside (WS) end. Concrete U-shaped headwall on each end. Grouted riprap apron on the landside (LS) end. Grouted riprap spillway on the WS end. [Additional Reference(s): DWR Levee Log, 1992. USACE Sacramento O&M Manual 504, May 1965, (HLM 4.77)]. FS Date: 2/25/2014

WS view: U type concrete headwall, pipe, and flapgate on levee slope.  
Soil/mud on outlet box.

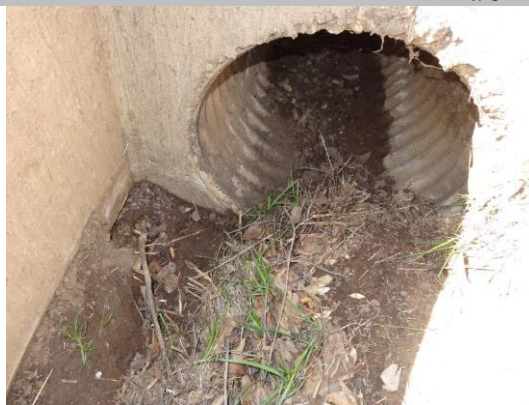
Photo 2 of 3 : UCIP\_SP\_2019\_31028\_56912.jpg

LS view: U type concrete headwall and CMP on levee slope.

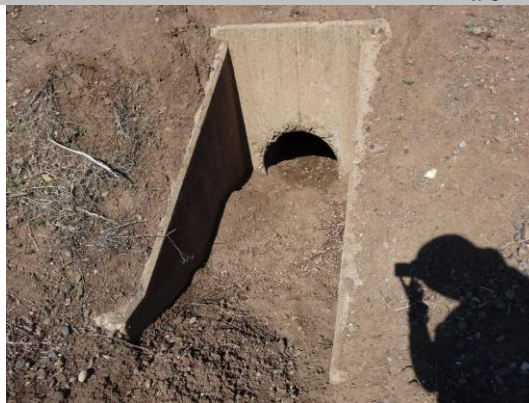
Photo 2 of 3 : UCIP\_SP\_2019\_31031\_56916.jpg

LM Start	5.64	Rating **	M	Issue No.	56 (cont)	
LM End	5.64	Issue Type +	Ma	Location *		
Category	Supplemental			GPS Latitude/Longitude		
				Start		End
Item	DWR UCIP LMA Responsibility			39.738898 °		39.738898 °
				-121.930242 °		-121.930242 °
DWR ID	19247					
Comment Code						
Inspector Comment						
FS_ID:31031 DS_ID:19247 EP_NO: N/A Repair Type: Non-Urgent Crossing Status: Found UCIP Comments: Needs cleaning and clearing of debris. FIELD_STRUCT_DESC: 24-inch corrugated metal gravity drainage pipe through the levee, 11.5 feet below the crown. Flap gate on the waterside (WS) end. Concrete U-shaped headwall on each end. Grouted riprap apron on the landside (LS) end. Grouted riprap spillway on the WS end. [Additional Reference(s): DWR Levee Log, 1992. USACE Sacramento O&M Manual 504, May 1965, (HLM 5.83)]. FS Date: 2/25/2014

LS view: U type concrete headwall and CMP on levee slope. Soil/mud on inlet box.

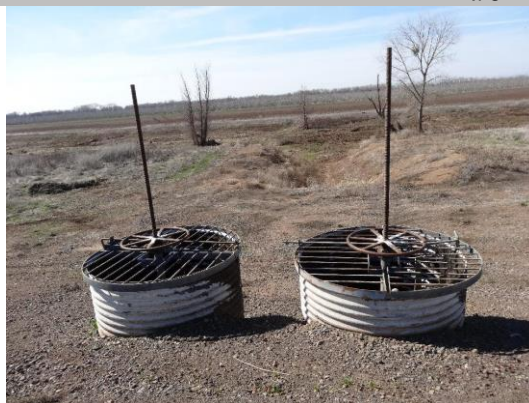
Photo 1 of 3 : UCIP\_SP\_2019\_41376\_56920.jpg

Comment Code						
Inspector Comment						
FS_ID:41376 DS_ID:19248 EP_NO: N/A Repair Type: Non-Urgent Crossing Status: Found UCIP Comments: Needs cleaning and clearing of debris. FIELD_STRUCT_DESC: [Channel Slough Drainage Structure] 1 of 2: 42-inch corrugated metal gravity drainage pipe through the levee, 16 feet below the crown. Flap gate on the waterside (WS) end. Slide gate in a corrugated metal pipe (CMP) riser on the WS slope. Concrete U-shaped headwall on each end. Grouted riprap apron and rock revetment on the landside (LS) end. [Additional Reference(s): DWR Levee Log, 1992. USACE Sacramento O&M Manual 504, May 1965, (HLM 6.30)]. FS Date: 2/25/2014

WS view: slide gates in CMP risers on levee slope.

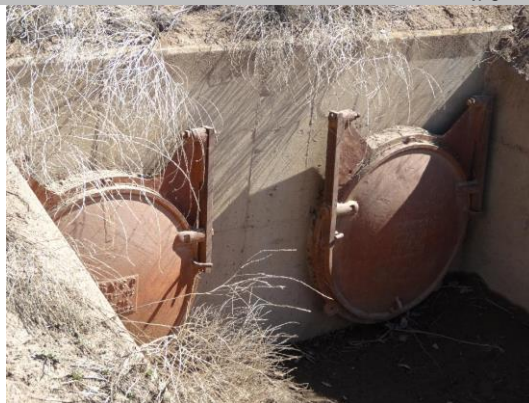
Photo 2 of 3 : UCIP\_SP\_2019\_41376\_56919.jpg

Comment Code						
Inspector Comment						
FS_ID:41376 DS_ID:19248 EP_NO: N/A Repair Type: Non-Urgent Crossing Status: Found UCIP Comments: Needs cleaning and clearing of debris. FIELD_STRUCT_DESC: [Channel Slough Drainage Structure] 1 of 2: 42-inch corrugated metal gravity drainage pipe through the levee, 16 feet below the crown. Flap gate on the waterside (WS) end. Slide gate in a corrugated metal pipe (CMP) riser on the WS slope. Concrete U-shaped headwall on each end. Grouted riprap apron and rock revetment on the landside (LS) end. [Additional Reference(s): DWR Levee Log, 1992. USACE Sacramento O&M Manual 504, May 1965, (HLM 6.30)]. FS Date: 2/25/2014

WS view: U type concrete headwall, pipes, and flapgates on levee slope. Vegetation debris on outlet box.

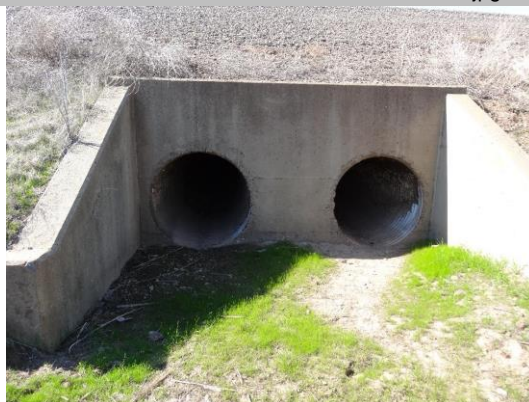
Photo 3 of 3 : UCIP\_SP\_2019\_41376\_56918.jpg

LS view: U type concrete headwall and CMPs on levee slope. Soil/mud on inlet box.

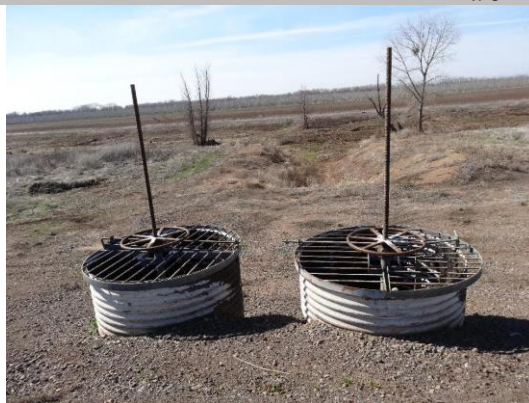
Photo 1 of 3 : UCIP\_SP\_2019\_41377\_56923.jpg

Comment Code						
Inspector Comment						
FS_ID:41377 DS_ID:19259 EP_NO: N/A Repair Type: Non-Urgent Crossing Status: Found UCIP Comments: Needs cleaning and clearing of debris. FIELD_STRUCT_DESC: [Channel Slough Drainage Structure] 2 of 2: 42-inch corrugated metal gravity drainage pipe through the levee, 16 feet below the crown. Flap gate on the waterside (WS) end. Slide gate in a corrugated metal pipe (CMP) riser on the WS slope. Concrete U-shaped headwall on each end. Grouted riprap apron and rock revetment on the landside (LS) end. [Additional Reference(s): DWR Levee Log, 1992. USACE Sacramento O&M Manual 504, May 1965, (HLM 6.30)]. FS Date: 2/25/2014

WS view: slide gates in CMP risers on levee slope.

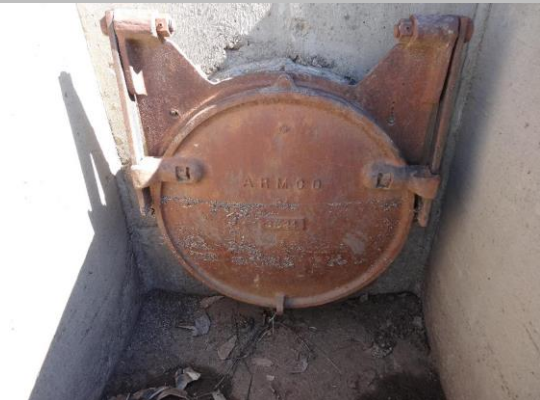
Photo 1 of 3 : UCIP\_SP\_2019\_31034\_56926.jpg

LM Start	6.15	Rating **	M	Issue No.	59
LM End	6.15	Issue Type +	Ma	Location *	
Category	Supplemental			GPS Latitude/Longitude	
				Start	End
Item	DWR UCIP LMA Responsibility			39.732515 °	39.732515 °
				-121.930373 °	-121.930373 °
DWR ID	19249				
Comment Code					
Inspector Comment					
FS_ID:31034 DS_ID:19249 EP_NO: N/A Repair Type: Non-Urgent Crossing Status: Found UCIP Comments: Needs cleaning and clearing of debris. FIELD_STRUCT_DESC: 24-inch corrugated metal gravity drainage pipe through the levee, 12 feet below the crown. Flap gate on the waterside (WS) end. Concrete U-shaped headwall on each end. Grouted riprap apron on the landside (LS) end. Grouted riprap spillway on the WS end. [Additional Reference(s): DWR Levee Log, 1992. USACE Sacramento O&M Manual 504, May 1965, (HLM 6.35)]. FS Date: 2/25/2014

WS view: U type concrete headwall, pipe, and flapgate on levee slope.

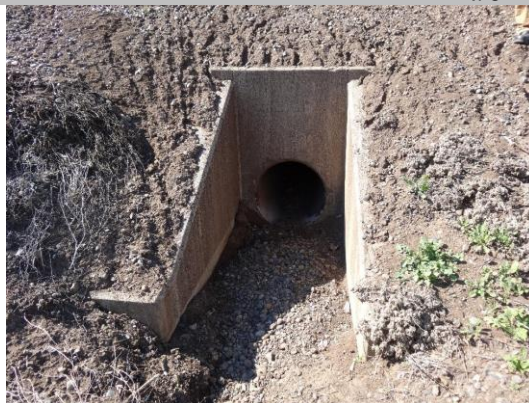
Photo 2 of 3 : UCIP\_SP\_2019\_31034\_56925.jpg

LS view: U type concrete headwall and CMP on levee slope.

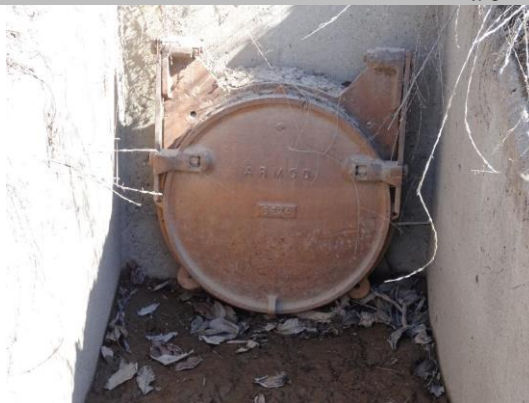
Photo 1 of 3 : UCIP\_SP\_2019\_31085\_56988.jpg

LM Start	6.43	Rating **	M	Issue No.	60
LM End	6.43	Issue Type +	Ma	Location *	
Category	Supplemental			GPS Latitude/Longitude	
				Start	End
Item	DWR UCIP LMA Responsibility			39.728812 °	39.728812 °
				-121.932623 °	-121.932623 °
DWR ID	19251				
Comment Code					
Inspector Comment					
FS_ID:31085 DS_ID:19251 EP_NO: N/A Repair Type: Non-Urgent Crossing Status: Found UCIP Comments: Needs cleaning and clearing of debris. FIELD_STRUCT_DESC: 24-inch corrugated metal gravity drainage pipe through the levee, 15.5 feet below the crown. Flap gate on the waterside (WS) end. Concrete U-shaped headwall on each end. Grouted riprap apron on the landside (LS) end. Grouted riprap spillway on the WS end. [Additional Reference(s): DWR Levee Log, 1992. USACE Sacramento O&M Manual 504, May 1965, (HLM 6.65)]. FS Date: 2/25/2014

WS view: U type concrete headwall, pipe, and flapgate on levee slope. Soil/mud on outlet box.

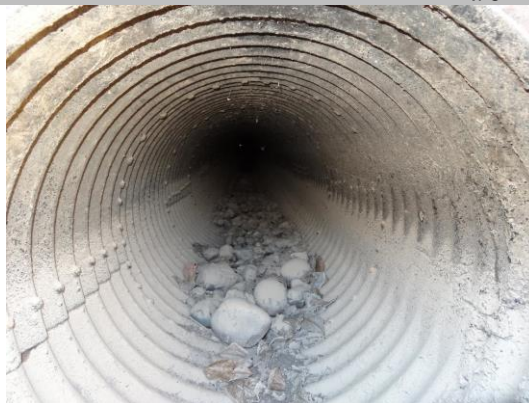
Photo 3 of 3 : UCIP\_SP\_2019\_31085\_56986.jpg

LM Start	6.43	Rating **	M	Issue No.	60 (cont)	
LM End	6.43	Issue Type +	Ma	Location *		
Category	Supplemental			GPS Latitude/Longitude		
				Start		End
Item	DWR UCIP LMA Responsibility			39.728812 °		39.728812 °
				-121.932623 °		-121.932623 °
DWR ID	19251					
Comment Code						
Inspector Comment						
FS_ID:31085 DS_ID:19251 EP_NO: N/A Repair Type: Non-Urgent Crossing Status: Found UCIP Comments: Needs cleaning and clearing of debris. FIELD_STRUCT_DESC: 24-inch corrugated metal gravity drainage pipe through the levee, 15.5 feet below the crown. Flap gate on the waterside (WS) end. Concrete U-shaped headwall on each end. Grouted riprap apron on the landside (LS) end. Grouted riprap spillway on the WS end. [Additional Reference(s): DWR Levee Log, 1992. USACE Sacramento O&M Manual 504, May 1965, (HLM 6.65)]. FS Date: 2/25/2014

LS view: inside view of CMP on levee slope. Needs cleaning and clearing.

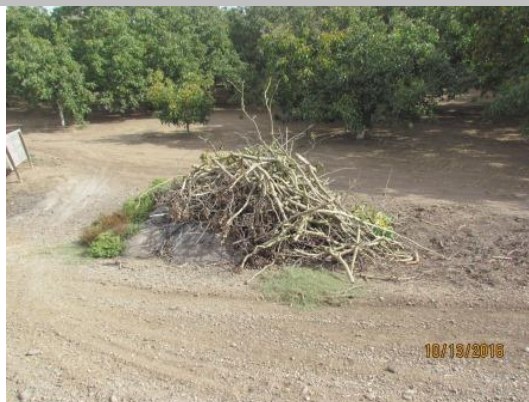
Photo 1 of 1 : SP\_2019\_NA0003\_65\_37\_20190325\_00009.jpg

LM Start	6.44	Rating **	M	Issue No.	37
LM End	6.44	Issue Type +	En	Location *	LS
Category	Earthen Levee			GPS Latitude/Longitude	
				Start	End
Item	Encroachments			39.728779 °	39.728779 °
				-121.932679 °	-121.932679 °
DWR ID	DWR_NA0003_02_f_2016_37				
Comment Code					
PR : Prunings					
Inspector Comment					
The prunings should be removed from the landside toe.

View of the prunings along the landside toe.

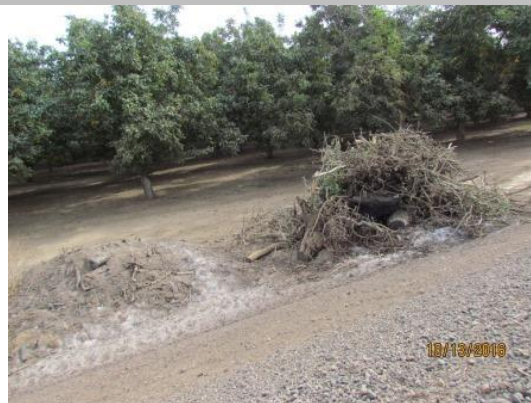
Photo 1 of 1 : SP\_2019\_NA0003\_65\_38\_20190325\_00010.jpg

LM Start	6.71	Rating **	M	Issue No.	38
LM End	6.71	Issue Type +	En	Location *	LS
Category	Earthen Levee			GPS Latitude/Longitude	
				Start	End
Item	Encroachments			39.725695 °	39.725695 °
				-121.935791 °	-121.935791 °
DWR ID	DWR_NA0003_02_f_2016_38				
Comment Code					
PR : Prunings					
Inspector Comment					
The prunings should be removed from the landside toe.

View of the prunings along the landside toe.

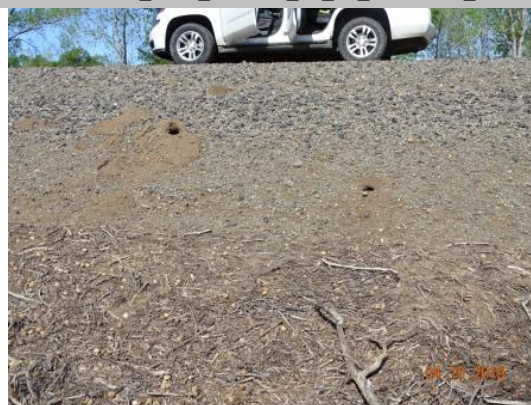
Photo 1 of 1 : SP\_2019\_NA0003\_65\_45\_20190415\_00066.jpg

LM Start	6.72	Rating **	M	Issue No.	45
LM End	6.72	Issue Type +	Ma	Location *	LS
Category	Earthen Levee			GPS Latitude/Longitude	
				Start	End
Item	Animal Control			39.725540 °	39.725540 °
				-121.935924 °	-121.935924 °
DWR ID	DWR_NA0003_02_s_2019_45				
Comment Code					
A3 : No rodents visible, but rodent burrows visible; need to backfill and compact or grout burrows.					
Inspector Comment

View of the rodent holes on the landside slope. Spring 2019.

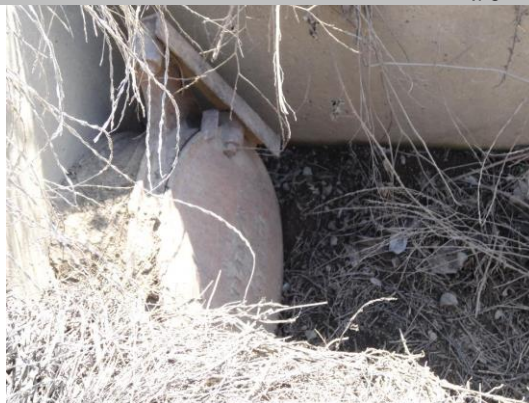
Photo 1 of 3 : UCIP\_SP\_2019\_31103\_57002.jpg

LM Start	6.94	Rating **	M	Issue No.	61
LM End	6.94	Issue Type +	Ma	Location *	
Category	Supplemental			GPS Latitude/Longitude	
				Start	End
Item	DWR UCIP LMA Responsibility			39.722798 °	39.722798 °
				-121.937828 °	-121.937828 °
DWR ID	19252				
Comment Code					
Inspector Comment					
FS_ID:31103 DS_ID:19252 EP_NO: N/A Repair Type: Non-Urgent Crossing Status: Found UCIP Comments: Needs cleaning and clearing of debris. FIELD_STRUCT_DESC: 24-inch corrugated metal gravity drainage pipe through the levee, 15 feet below the crown. Flap gate on the waterside (WS) end. Concrete U-shaped headwall on each end. Grouted riprap apron on the landside (LS) end. Grouted riprap spillway on the WS end. [Additional Reference(s): DWR Levee Log, 1992. USACE Sacramento O&M Manual 504, May 1965, (HLM 7.17)]. FS Date: 2/25/2014

WS view: U type concrete headwall, pipe, and flapgate on levee slope. Soil/mud on outlet box. Vegetation debris blocking outlet box

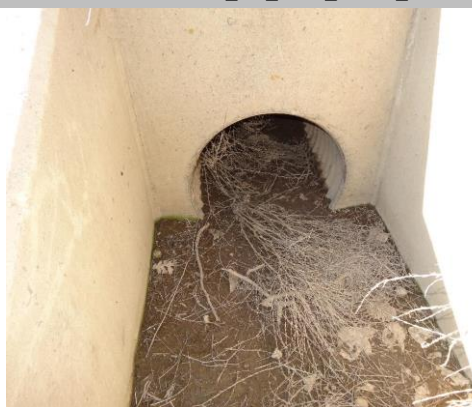
Photo 2 of 3 : UCIP\_SP\_2019\_31103\_57001.jpg

LS view: U type concrete headwall and CMP on levee slope. Soil/mud on inlet box.

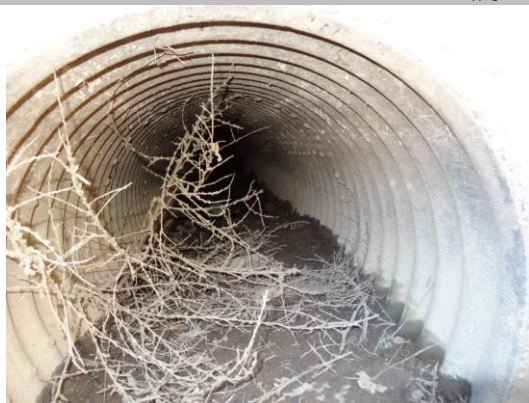
Photo 3 of 3 : UCIP\_SP\_2019\_31103\_57000.jpg

LM Start	6.94	Rating **	M	Issue No.	61 (cont)	
LM End	6.94	Issue Type +	Ma	Location *		
Category	Supplemental			GPS Latitude/Longitude		
				Start		End
Item	DWR UCIP LMA Responsibility			39.722798 °		39.722798 °
				-121.937828 °		-121.937828 °
DWR ID	19252					
Comment Code						
Inspector Comment						
FS_ID:31103 DS_ID:19252 EP_NO: N/A Repair Type: Non-Urgent Crossing Status: Found UCIP Comments: Needs cleaning and clearing of debris. FIELD_STRUCT_DESC: 24-inch corrugated metal gravity drainage pipe through the levee, 15 feet below the crown. Flap gate on the waterside (WS) end. Concrete U-shaped headwall on each end. Grouted riprap apron on the landside (LS) end. Grouted riprap spillway on the WS end. [Additional Reference(s): DWR Levee Log, 1992. USACE Sacramento O&M Manual 504, May 1965, (HLM 7.17)]. FS Date: 2/25/2014

LS view: inside view of CMP on levee slope. Needs cleaning and clearing.

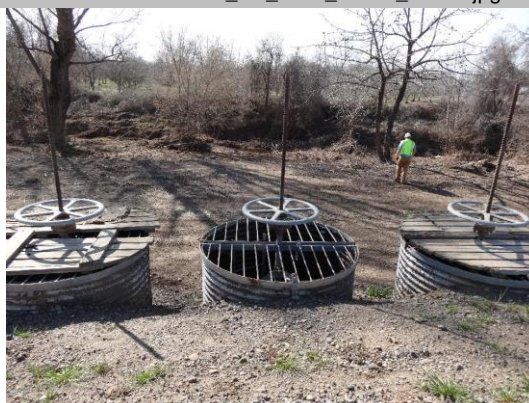
Photo 1 of 3 : UCIP\_SP\_2019\_32085\_58585.jpg

Comment Code					
Inspector Comment					
FS_ID:32085 DS_ID:19253 EP_NO: N/A Repair Type: Non-Urgent Crossing Status: Found UCIP Comments: Slide gates in CMP risers on waterside shoulder.Needs cleaning and clearing of debris. FIELD_STRUCT_DESC: 1 of 3: 48-inch corrugated metal gravity drainage pipe through the levee, 18 feet below the crown. Flap gate on the waterside (WS) end. Slide gate in a corrugated metal pipe (CMP) riser on the WS shoulder. Concrete U-shaped headwall on each end. Grouted riprap apron on the landside (LS) end. Grouted riprap spillway on the WS end. [Additional Reference(s): DWR Levee Log, 1992. USACE Sacramento O&M Manual 504, May 1965, (HLM 7.46)]. FS Date: 2/25/2014

WS view: slide gates in CMP risers on waterside shoulder.
